Explosive Decompression with Resultant Air Gas Embolism in a Fourth Generation Fighter at Ground Level

Joe X. Zhang; Jacob R. Berry; Devin P. Beckstrand

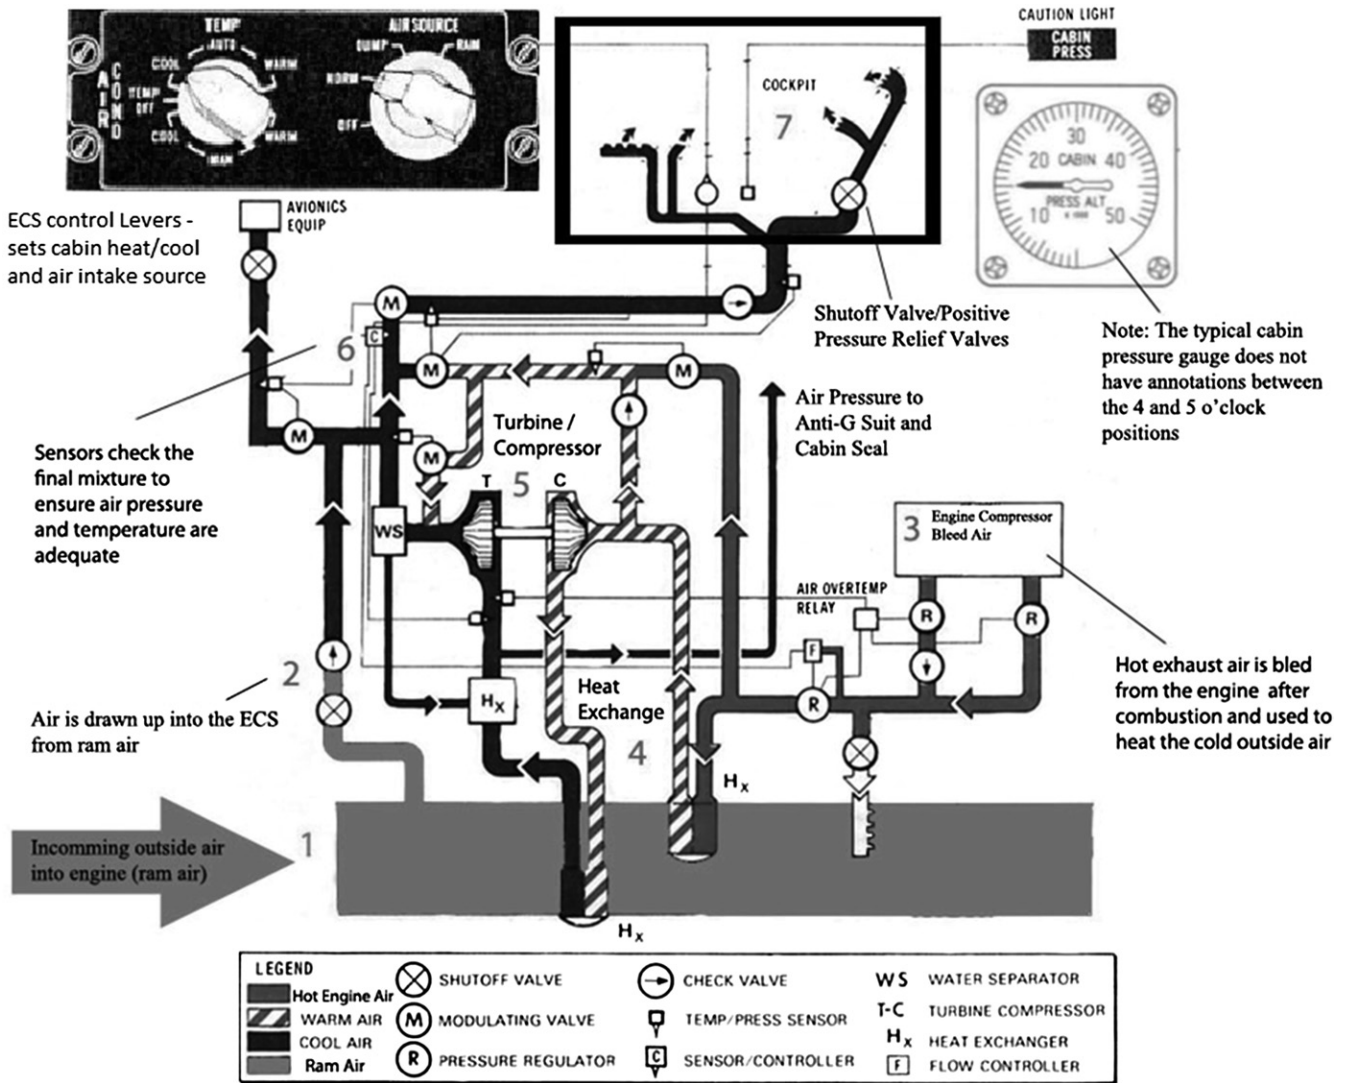
Fig. 1. Typical environmental control system flow diagram. 1) Air enters the aircraft through a ram air intake nozzle at the exterior of the aircraft. 2) The air flows up and continues into the cabin if it is of sufficient temperature and pressure. 3) Hot engine exhaust warms cold intake air at high altitude via heat exchange tubes at location 4. 5) Air compressors and turbines regulate the amount of airflow and pressure. 6) Sensors ensure temperature and pressure. 7) Cabin pressure is further adjusted by pressure relief valves.

The ECS in this case clearly malfunctioned. For the event to occur, the positive pressure relief valves at position 7 likely failed. In addition, either the computerized control sensors at position 6 must have also failed to detect the increased pressures and continued to operate the compressor pump at position 5 or the compressor may have failed to respond to a shutoff signal. This event would require at least two or more redundant safety systems to fail simultaneously, which accounts for its rarity. While the ECS was turned off earlier, the pilot kept the engine on, which could also further complicate the situation as a lot of the air pressure comes directly from the engine intakes. A complete teardown and inspection of the ECS system on this aircraft, unfortunately, identified no failed components. After reassembly and inspection, this aircraft returned to service and reported no further ECS malfunctions to date.

On review of this case, we realized a lack of understanding of this type of event from aircrew and emergency responders. Should future pilots find themselves in an overpressurized cockpit on the ground, we recommend they immediately shut down the ECS along with the aircraft engine, and wait inside a closed cabin until cockpit pressurization normalizes to ground level. This will allow the canopy seal air leak to slowly equilibrate to outside pressures and reduce the risk of rapid decompression. Breathing supplemental 100% oxygen would add an additional protective factor. If potential for rapid or explosive decompression is unavoidable, the pilot should avoid breath holding during canopy or hatch opening. Most, if not all aircraft, have a manual exhaust valve that maintenance personnel can access or a pilot operated dump valve on the ECS controls. Crews must take care when using these options to reduce excess cockpit pressure at a controlled rate over several minutes to reduce risk of rapid decompression. This information should be useful for development of future emergency response checklists.
