Instrument Failure, Stress, and Spatial Disorientation Leading to a Fatal Crash With a Large Aircraft

Arne Tribukait; Ola Eiken

Tribukait A, Eiken O. Instrument failure, stress, and spatial disorientation leading to a fatal crash with a large aircraft. *Aerosp Med Hum Perform*. 2017;88(11):1043–1048.

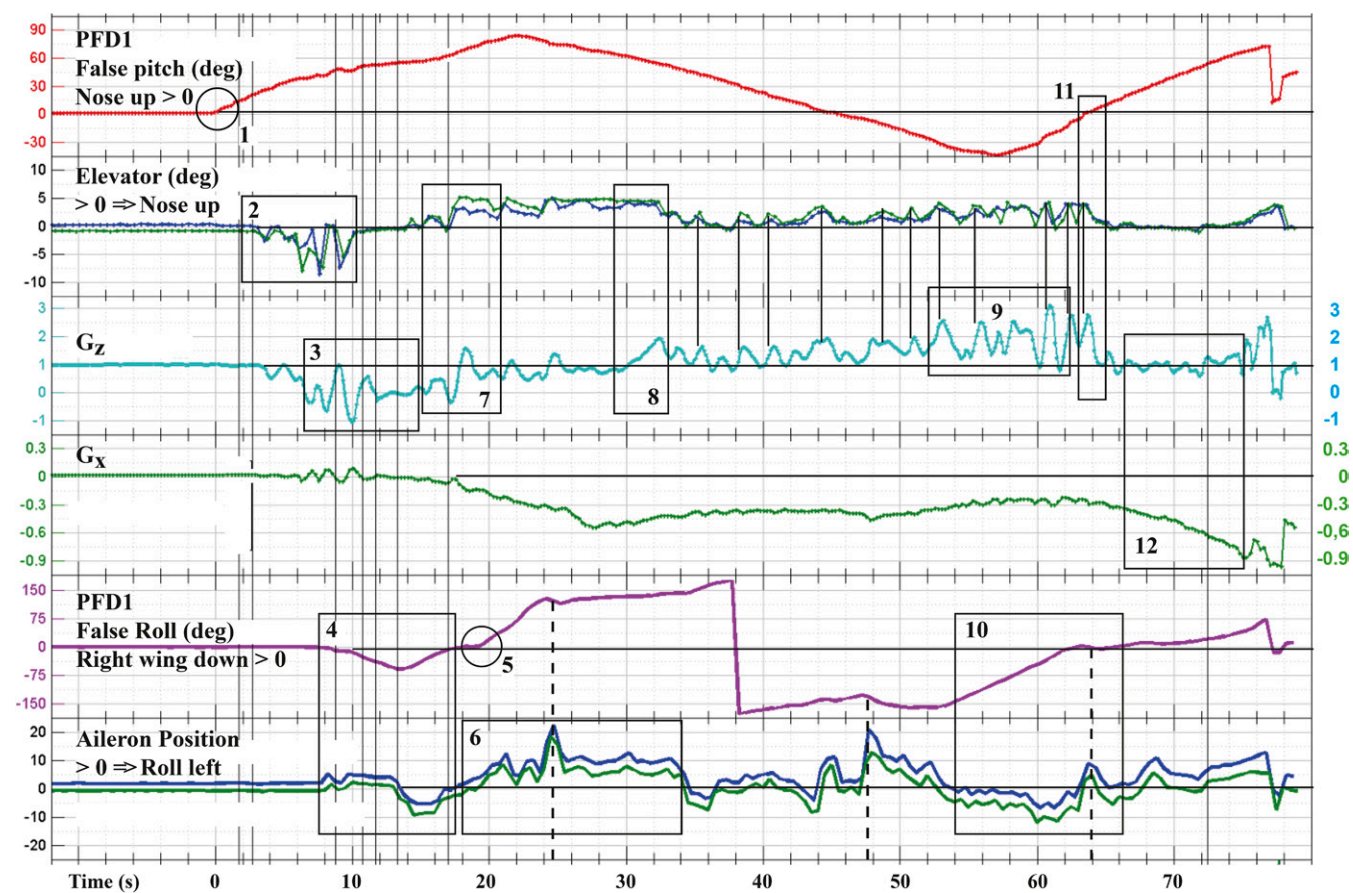
Notably, recorded roll and pitch attitude (**Fig. 1**), obtained from the DFDR, represent the malfunctioning inertial reference unit 1; they were presented on the primary flight display 1 (PFD1) in front of the pilot in command, who was pilot flying. For inertial reference unit 2, which most likely was functioning adequately, there are no corresponding recordings. Based on other flight data, estimates of the real attitude, as presented on PFD2 (in front of the first officer, who was monitoring), have

Fig. 1. Selection of DFDR variables (adapted from Appendix 1, Ref. 8). Critical events, phenomena, and relationships are highlighted by circles, squares and lines. Pitch and roll represent the malfunctioning PFD1 (there are no recordings from PFD2, which most likely was functioning correctly). 1) Sudden pitch-up indication. 2) The response of pilot flying with the control column. 3) Reduced/negative G_z . 4) Aileron deflection causing temporary left-roll. 5) Erroneous roll-right indication. 6) Pilot flying tries to correct for indicated roll. 7) Due to nose-down trim pilot flying must pull the control column in order to achieve $G_z = 1$. 8) At t_{30-33} nose-down trim is reduced, making it possible to maintain 1 G_z with elevators in neutral position. 9) Pronounced increase in G_z as the aircraft enters a right-turn; fluctuations might interfere with reading functioning instruments. 10) PFD indicates that the aircraft is approaching level flight from an extreme left-bank; aileron deflections suggest that pilot flying tries to facilitate this roll movement and to stop it at 0°. 11) When indicated pitch is 0° elevators return to neutral position and G_z to 1.0. 12) The situation at t_{63} has similarities with that at t_0 , but now pilot flying does not respond to the indicated pitch up; while G_z is constant, there is an increasing negative value of G_x , possibly inducing a sensation of forward tilting from upright position. Continuous vertical lines show how peaks in G_z are preceded by peaks in elevator position. Dashed vertical lines highlight the association between extreme aileron deflections and marked reductions in indicated roll-right rotation.

Pilot flying (PF) had commenced approach briefing and pilot monitoring (PM) was confirming when, shortly after midnight, DFDR recorded a sudden increase in the aircraft's pitch attitude (Fig. 1;1). This erroneous information was presented on PFD1 (in front of PF) but not on PFD2. The discrepancy between the PFDs automatically disengaged the autopilot, generating acoustic warning signals (Fig. 2). After 2 s (at t_2) the pitch-up, indicated by PFD1, was 15°, but altitude and speed remained unchanged. PF

uttered an exclamation of astonishment and reacted instantaneously by pushing the control column; at t_3 , the elevators were deflected in the nose-down direction and the stabilizer was trimmed nose-down (Fig. 1;2). Notwithstanding, the indicated pitch-up increased, exceeding 30° at t_5 . In addition, red arrows, calling for a nose-down input, appeared on PFD1 (probably also on PFD2, but pointing oppositely). A high rate of descent followed. G_z (the component of the gravito-inertial force vector acting in the head-to-seat direction) declined; during approximately 10 s it was ≤ 0 , with a minimum of -1.0 (Fig. 1;3). In conjunction with transitions between positive and negative G_z , irregular sounds from loose objects in the cockpit were recorded by the cockpit voice recorder. Registered roll displayed a left-banking with a maximum of 50° (Fig. 1;4); acoustic bank-angle warnings sounded and PM said "Turn right." At t_{17} , maximum operating speed (315 kn) was exceeded, activating the overspeed warning. At t_{18} , the aircraft's roll position was again 0°. So far, PFD1 was correctly indicating the roll attitude.

At t_{20} PFD1 began to display, erroneously, a rapid right-wing-down roll rotation (Fig. 1;5); exceeding 110° at t_{24} . This indicated roll motion continued, with irregularities, during the remaining course of events (exceeding 400°). At t_{20-23} , bank-angle warnings sounded and PM said “Turn left.” During t_{20-34} , DFDR recorded aileron deflections of great magnitude, as for rolling left (Fig. 1;6). The effect was, according to calculations,⁸ that the aircraft, whose roll position at t_{20} was close to zero, at t_{24} was tilted left-wing down 140° . At this moment the aircraft was, according to calculations, pitched nose-down by almost 40° , but PFD1 indicated a pitch-up of 80° .

After t_{50} there was, according to the 3-D graph, a right-turn with decreasing radius. During t_{52-64} , G_z was approximately 2, with vigorous fluctuations and peaks of 3 G (Fig. 1;9). The graphs representing the malfunctioning attitude indicator of PFD1, elevators, ailerons and G_z display certain noticeable relationships. PFD1 indicated that the aircraft at t_{54} had a very large left-bank, but that there was a rightward roll rotation. Aileron deflections are compatible with an intention of PF to perform such a movement, with a brief counter-action when indicated roll was 0° (Fig. 1;10). The indicated roll rotation was, in fact, stopped at that very moment. For a short while (t_{63-64}) also indicated pitch was 0° , and PF saw on his attitude indicator that the aircraft was horizontal in pitch and roll. Concomitantly, the elevators returned to the position of straight-ahead level flight and G_z abruptly decreased to 1.0 (Fig. 1;11), remaining nearly constant until the aircraft hit the ground, at t_{77} .

As to the maneuverability of the aircraft at high speeds (for which aerodynamic knowledge is limited), two observations suggest that the aircraft was, in fact, maneuverable until the end. Firstly, peaks in G_z were preceded (with a fraction of a second) by peaks in elevator position (Fig. 1). Thus, variations in G_z were due to activities of the pilots and the elevators were functioning adequately. When the nose-down trim of the stabilizer was reduced at t_{30-33} , G_z increased (Fig. 1;8). The increasing trend of G_z and the fact that G_z was +1 during the last inverted phase implies that the wings gave their usual lift. Secondly, at moments when the ailerons displayed particularly large left-wing-down deflections, there were notable reductions in the roll-right rotation indicated by PFD1 (Fig. 1). Thus, even if inertial reference unit 1 did not provide correct information on the aircraft's attitude it was not insensitive to roll movements, and the aileron deflections had an effect in the direction desired by PF.
