# Instrument Failure, Stress, and Spatial Disorientation Leading to a Fatal Crash With a Large Aircraft

Arne Tribukait; Ola Eiken

Tribukait A, Eiken O. *Instrument failure, stress, and spatial disorientation leading to a fatal crash with a large aircraft.* *Aerosp Med Hum Perform.* 2017;88(11):1043–1048.

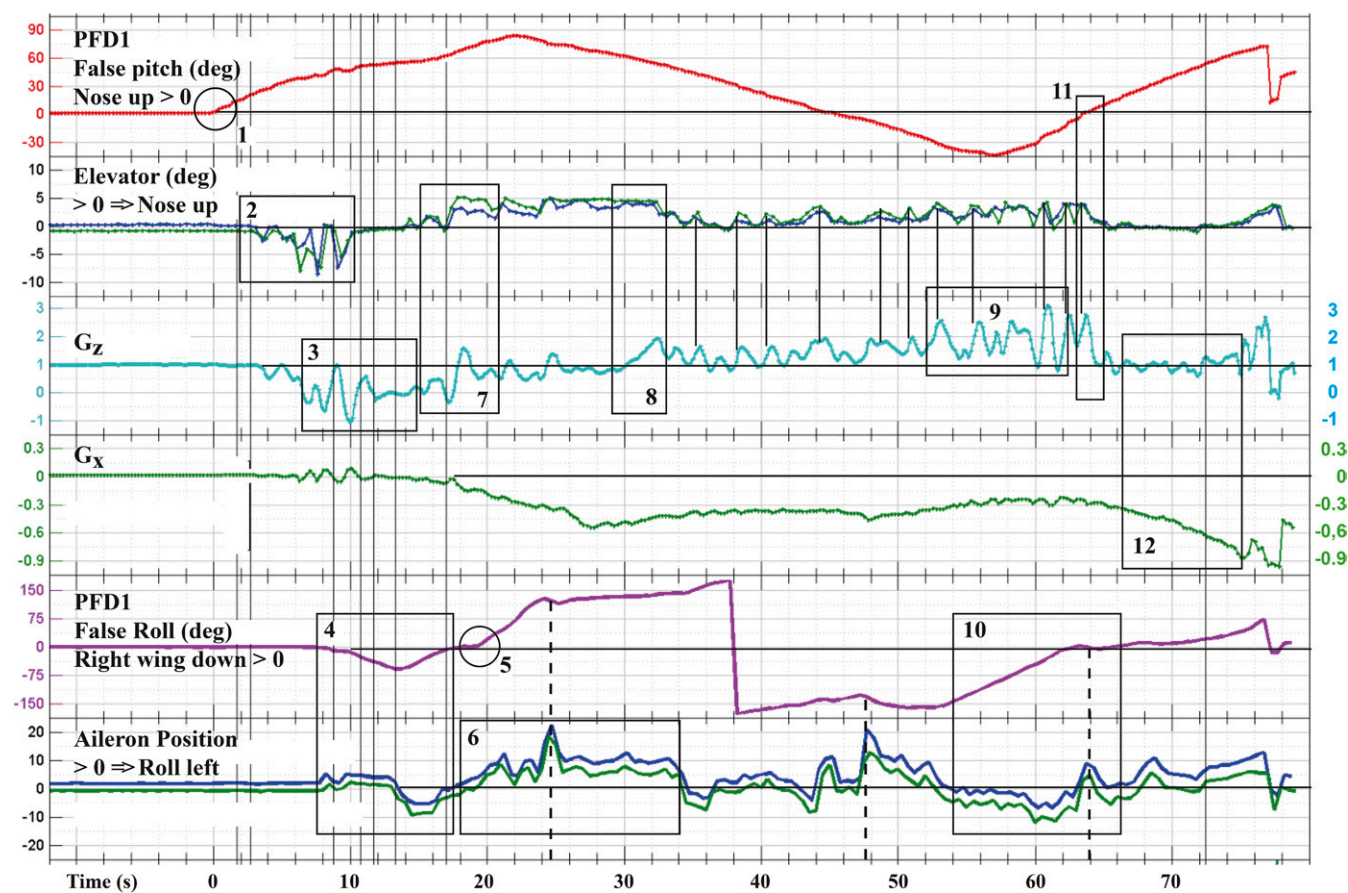
Notably, recorded roll and pitch attitude (**Fig. 1**), obtained from the DFDR, represent the malfunctioning inertial reference unit 1; they were presented on the primary flight display 1 (PFD1) in front of the pilot in command, who was pilot flying. For inertial reference unit 2, which most likely was functioning adequately, there are no corresponding recordings. Based on other flight data, estimates of the real attitude, as presented on PFD2 (in front of the first officer, who was monitoring), have

**Fig. 1.** Selection of DFDR variables (adapted from Appendix 1, Ref. 8). Critical events, phenomena, and relationships are highlighted by circles, squares and lines. Pitch and roll represent the malfunctioning PFD1 (there are no recordings from PFD2, which most likely was functioning correctly). 1) Sudden pitch-up indication. 2) The response of pilot flying with the control column. 3) Reduced/negative  $G_z$ . 4) Aileron deflection causing temporary left-roll. 5) Erroneous roll-right indication. 6) Pilot flying tries to correct for indicated roll. 7) Due to nose-down trim pilot flying must pull the control column in order to achieve  $G_z = 1$ . 8) At  $t_{30-33}$  nose-down trim is reduced, making it possible to maintain 1  $G_z$  with elevators in neutral position. 9) Pronounced increase in  $G_z$  as the aircraft enters a right-turn; fluctuations might interfere with reading functioning instruments. 10) PFD indicates that the aircraft is approaching level flight from an extreme left-bank; aileron deflections suggest that pilot flying tries to facilitate this roll movement and to stop it at  $0^\circ$ . 11) When indicated pitch is  $0^\circ$  elevators return to neutral position and  $G_z$  to 1.0. 12) The situation at  $t_{63}$  has similarities with that at  $t_0$ , but now pilot flying does not respond to the indicated pitch up; while  $G_z$  is constant, there is an increasing negative value of  $G_x$ , possibly inducing a sensation of forward tilting from upright position. Continuous vertical lines show how peaks in  $G_z$  are preceded by peaks in elevator position. Dashed vertical lines highlight the association between extreme aileron deflections and marked reductions in indicated roll-right rotation.

Pilot flying (PF) had commenced approach briefing and pilot monitoring (PM) was confirming when, shortly after midnight, DFDR recorded a sudden increase in the aircraft's pitch attitude (Fig. 1;1). This erroneous information was presented on PFD1 (in front of PF) but not on PFD2. The discrepancy between the PFDs automatically disengaged the autopilot, generating acoustic warning signals (Fig. 2). After 2 s (at  $t_2$ ) the pitch-up, indicated by PFD1, was  $15^\circ$ , but altitude and speed remained unchanged. PF

uttered an exclamation of astonishment and reacted instantaneously by pushing the control column; at  $t_3$ , the elevators were deflected in the nose-down direction and the stabilizer was trimmed nose-down (Fig. 1;2). Notwithstanding, the indicated pitch-up increased, exceeding  $30^\circ$  at  $t_5$ . In addition, red arrows, calling for a nose-down input, appeared on PFD1 (probably also on PFD2, but pointing oppositely). A high rate of descent followed.  $G_z$  (the component of the gravito-inertial force vector acting in the head-to-seat direction) declined; during approximately 10 s it was  $\leq 0$ , with a minimum of  $-1.0$  (Fig. 1;3). In conjunction with transitions between positive and negative  $G_z$ , irregular sounds from loose objects in the cockpit were recorded by the cockpit voice recorder. Registered roll displayed a left-banking with a maximum of  $50^\circ$  (Fig. 1;4); acoustic bank-angle warnings sounded and PM said "Turn right." At  $t_{17}$ , maximum operating speed (315 kn) was exceeded, activating the overspeed warning. At  $t_{18}$ , the aircraft's roll position was again  $0^\circ$ . So far, PFD1 was correctly indicating the roll attitude.

At  $t_{20}$  PFD1 began to display, erroneously, a rapid right-wing-down roll rotation (Fig. 1;5); exceeding  $110^\circ$  at  $t_{24}$ . This indicated roll motion continued, with irregularities, during the remaining course of events (exceeding  $400^\circ$ ). At  $t_{20-23}$ , bank-angle warnings sounded and PM said “Turn left.” During  $t_{20-34}$ , DFDR recorded aileron deflections of great magnitude, as for rolling left (Fig. 1;6). The effect was, according to calculations,<sup>8</sup> that the aircraft, whose roll position at  $t_{20}$  was close to zero, at  $t_{24}$  was tilted left-wing down  $140^\circ$ . At this moment the aircraft was, according to calculations, pitched nose-down by almost  $40^\circ$ , but PFD1 indicated a pitch-up of  $80^\circ$ .

After  $t_{50}$  there was, according to the 3-D graph, a right-turn with decreasing radius. During  $t_{52-64}$ ,  $G_z$  was approximately 2, with vigorous fluctuations and peaks of 3 G (Fig. 1;9). The graphs representing the malfunctioning attitude indicator of PFD1, elevators, ailerons and  $G_z$  display certain noticeable relationships. PFD1 indicated that the aircraft at  $t_{54}$  had a very large left-bank, but that there was a rightward roll rotation. Aileron deflections are compatible with an intention of PF to perform such a movement, with a brief counter-action when indicated roll was  $0^\circ$  (Fig. 1;10). The indicated roll rotation was, in fact, stopped at that very moment. For a short while ( $t_{63-64}$ ) also indicated pitch was  $0^\circ$ , and PF saw on his attitude indicator that the aircraft was horizontal in pitch and roll. Concomitantly, the elevators returned to the position of straight-ahead level flight and  $G_z$  abruptly decreased to 1.0 (Fig. 1;11), remaining nearly constant until the aircraft hit the ground, at  $t_{77}$ .

As to the maneuverability of the aircraft at high speeds (for which aerodynamic knowledge is limited), two observations suggest that the aircraft was, in fact, maneuverable until the end. Firstly, peaks in  $G_z$  were preceded (with a fraction of a second) by peaks in elevator position (Fig. 1). Thus, variations in  $G_z$  were due to activities of the pilots and the elevators were functioning adequately. When the nose-down trim of the stabilizer was reduced at  $t_{30-33}$ ,  $G_z$  increased (Fig. 1;8). The increasing trend of  $G_z$  and the fact that  $G_z$  was +1 during the last inverted phase implies that the wings gave their usual lift. Secondly, at moments when the ailerons displayed particularly large left-wing-down deflections, there were notable reductions in the roll-right rotation indicated by PFD1 (Fig. 1). Thus, even if inertial reference unit 1 did not provide correct information on the aircraft's attitude it was not insensitive to roll movements, and the aileron deflections had an effect in the direction desired by PF.

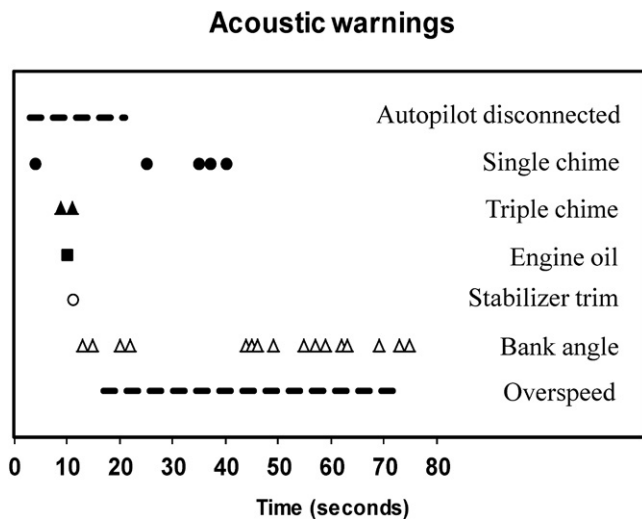
**Fig. 2.** Acoustic cautions and warnings during the course of events.

The pilots' calls and exclamations indicate that they initially were astonished and that the level of stress soon became very high. PF asked PM for help several times. PM sent distress calls. There were, however, no rational communication about the situation, and it appears that the pilots never compared the PFDs or checked the standby attitude indicator. In **Table I** the pilots' communication is related to DFDR data. The pilots were exposed to a large number of acoustic cautions and warnings (Fig. 2).

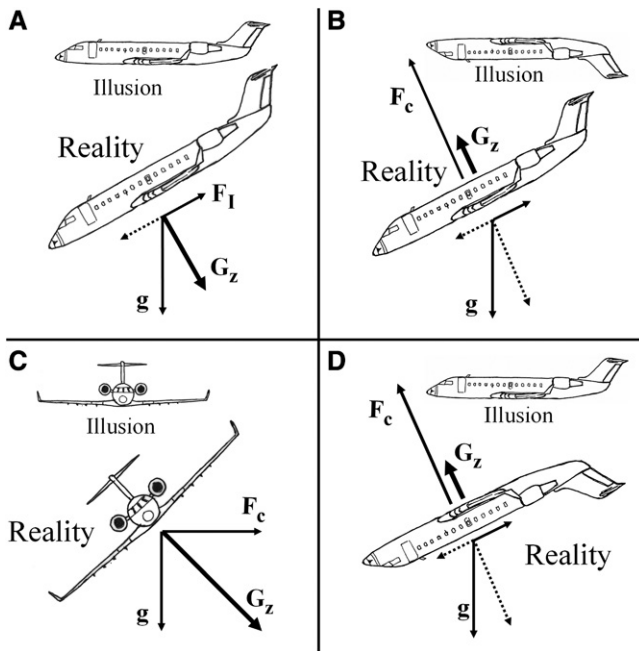
The second question is similar: Is it reasonable that the pilot did not feel the forward tilt of the aircraft resulting from his movement with the control column? Here, a longitudinal acceleration generates a backward inertial force (Fig. 3A) balancing the forward component of the Earth gravity force.<sup>2</sup> In the present case, the longitudinally oriented  $G_x$  (Fig. 1) did not deviate notably from the value during straight-ahead level flight until  $t_{18}$ , when the aircraft, in reality, was pitched down 25°. Thus, while the pilot observed an increasing pitch up on his PFD, he could not feel any forward tilt.

The pilot's attempt to counteract the indicated pitch up resulted in a curved trajectory with an inertial force directed upwards. The magnitude of this force soon exceeded the Z component of the Earth gravity force (Fig. 3B), and during approximately 10 s  $G_z$  was  $\leq 0$ , with a minimum of  $-1.0$ . In this situation pilots may experience an illusion of being upside-down,<sup>2,6</sup> hanging in the seat belts while loose objects fall to the ceiling. A plausible response to this inversion illusion is a roll maneuver. In the present case, there was a temporary left-bank with a maximum of 50° shortly after the nadir of  $G_z$ . This might have been due to an involuntary movement with the control column. PF asked for help and pilot monitoring (PM) replied: "Turn right"; a corrective aileron deflection followed and the aircraft's roll attitude was soon 0° again. By the end of

**Fig. 3.** Four cases of somatogravic illusion, illustrating the difficulties encountered by the pilots because of the equivalence between gravity and inertia. The Earth gravity force is represented by the vector  $g$ ; the  $x$  and  $z$  components of  $g$  are dotted. Inertial forces caused by longitudinal accelerations are denoted  $F_I$ , centrifugal forces  $F_c$ . The resultant  $G$  vector acting in the pilot's head-to-seat axis is denoted  $G_z$ . A) Illusion of level flight while actually being tilted pitch-down. The forward component of  $g$  accelerates the plane; because of  $F_I$  the pilot feels as if flying level. B) When the magnitude of an upward  $F_c$  exceeds the  $z$ -component of  $g$ ,  $G_z$  will be negative (pointing upwards), causing an illusion of inversion. C) During a coordinated turn  $G_z$  remains in the pilot's median plane, making it difficult to perceive the direction and magnitude of roll tilt. D) By the end of the course of events, the aircraft was inverted, but since an upward  $F_c$  exceeded the  $z$  component of  $g$ ,  $G_z$  was pointing in the head-to-seat direction.
