# Canadian Ultralight Accidents in Water (1990 to 2020)

Conor MacDonald; Christopher Brooks; Ross McGowan; Ari Rosberg

| INTRODUCTION: | Recently, an analysis of Canadian seaplane accidents terminating in water (1995–2019) was conducted, but ultralight water accidents were excluded due to differences from general aviation operations. This is the first literature that reports a series of ultralight accidents that occurred in water. The purpose of this paper is to identify the circumstances surrounding ultralight water accidents in Canada and to identify actions with the potential to improve survival. |
|---|---|
| | MacDonald C, Brooks C, McGowan R, Rosberg A. Canadian ultralight accidents in water (1990 to 2020). Aerosp Med Hum Perform. 2023;<br>94(6):437–443. |

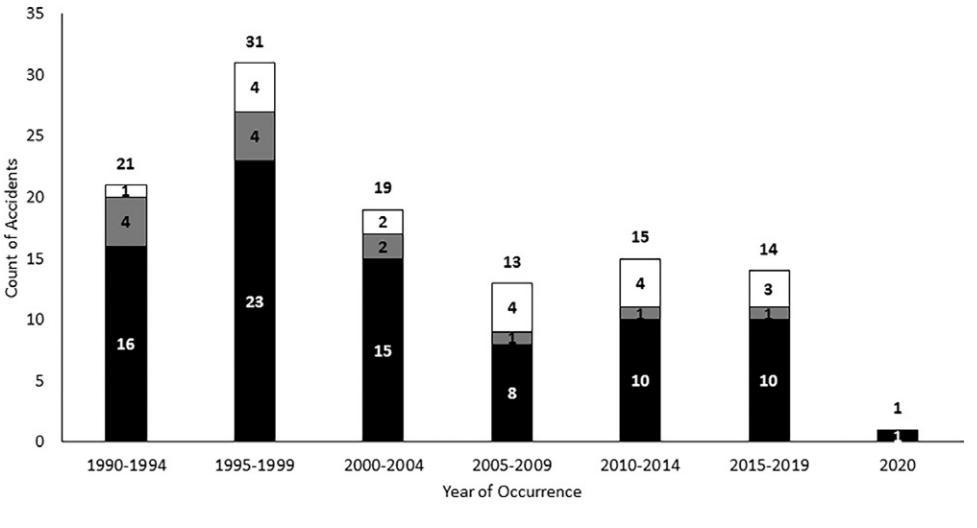
The number of accidents per year ranged from 0 (2011) to 13 (1997), with a median of 3 and an interquartile range of 3. **Fig. 1** shows the count of accidents per 5-yr span during this

Fig. 1. Count of ultralight accidents terminating in water annually.

time, stratified by the number of accidents in which at least one fatal/serious injury or only minor injury had occurred.
