Total Ankle Replacement in a Military Jet Pilot

Paola Verde; Stefano Guardigli; Fabio Morgagni; Steve Roberts; Donato Monopoli; Andrea Scala

Verde P, Guardigli S, Morgagni F, Roberts S, Monopoli D, Scala A. *Total ankle replacement in a military jet pilot. Aerosp Med Hum Perform.* 2020; 91(7):597–603.

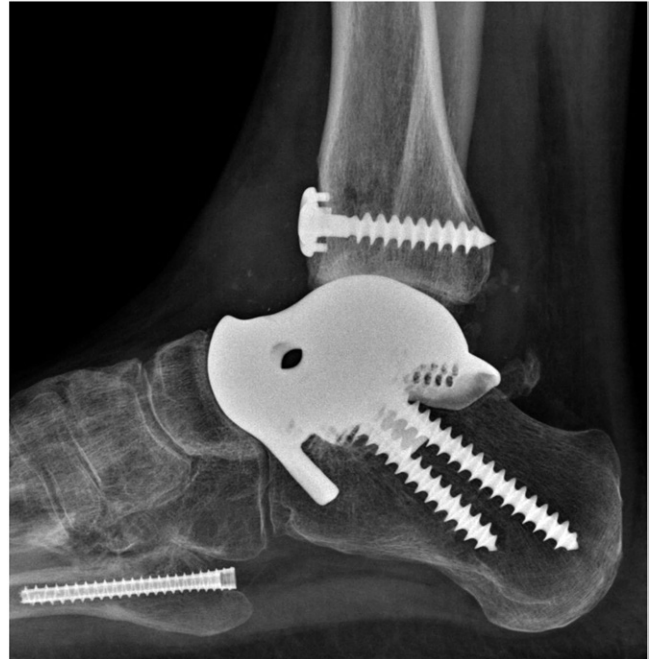
Fig. 2. Pre-op total ankle replacement: lateral view. The X-ray in lateral view shows the disappearance of the ankle joint space. The metallic talus is in contact with the tibial plafond. The reabsorption of articular cartilage is apparent.

The ankle range of movement (ROM) was blocked at 30° based on 80° dorsiflexion and 110° plantar flexion. The Achilles tendon was retracted. There were no pronosupination or inversion-eversion movements since the subtalar joint was blocked by two screws at the posterior talus-calcaneal joint. At the level of the right talonavicular joint the titanium talus was directly in contact with the cartilage surface of the navicular (**Fig. 1** and **Fig. 2**).

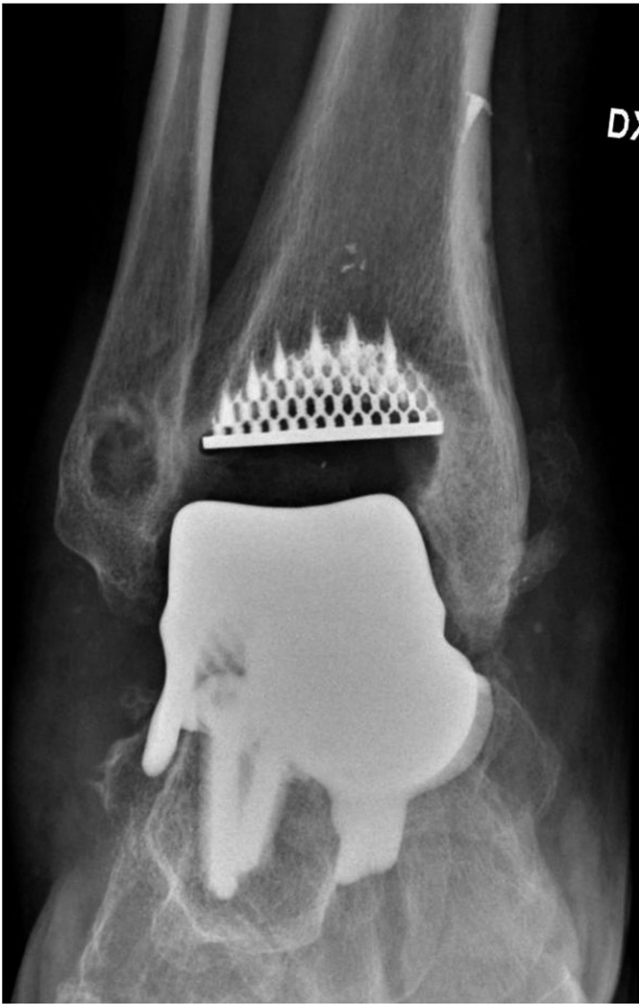
Fig. 3. Post-op total ankle replacement: frontal view. The postoperative frontal view radiograph of the ankle joint replacement shows the volume of the tibial implant and the alveolar shape. It was designed to fill the hole left in the distal tibia by the removal of the screw and ligament washer for ligament reconstruction. The polyethylene inlay has restored the joint space. The range of motion of the ankle is quite normal and the pain is absent or tolerable.

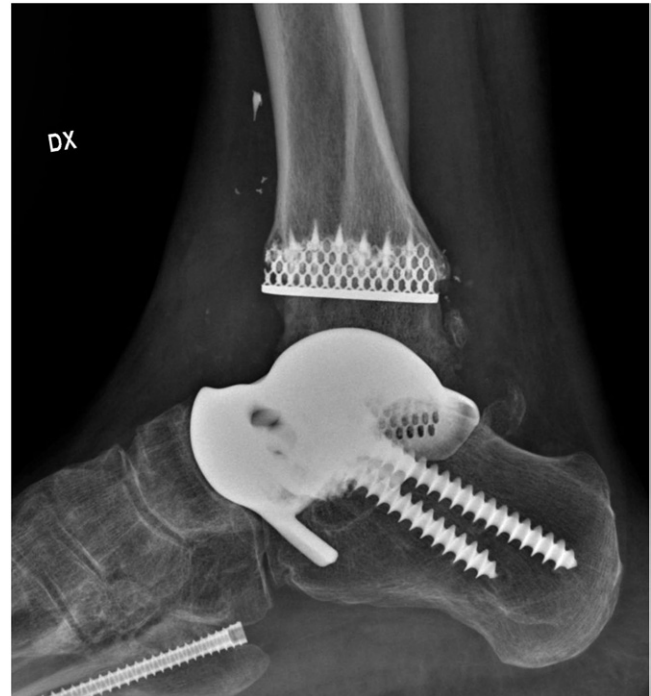
Fig. 4. Post-op total ankle replacement: lateral view. The postoperative lateral view radiograph of the ankle joint replacement shows the tibial component with its alveolar structure. The polyethylene inlay has restored the joint space.
