Total Ankle Replacement in a Military Jet Pilot

- INTRODUCTION:** A total ankle replacement in a jet pilot after an open, high-energy foot and ankle fracture and dislocation with talar extrusion in a plane crash was carefully evaluated before considering fitness to fly.

- CASE REPORT:** A 33-yr-old male test pilot of the Italian Air Force was involved in a plane crash and reported an open high-energy fracture/dislocation of the right ankle, with the expulsion of the right talus due to the impact, and other fractures. A titanium replica was inserted inside the ankle. However, the patient suffered from intolerable pain and developed arthritic changes in the cartilage of the tibial plafond. For these reasons, a decision was made to perform a custom-made total ankle replacement.

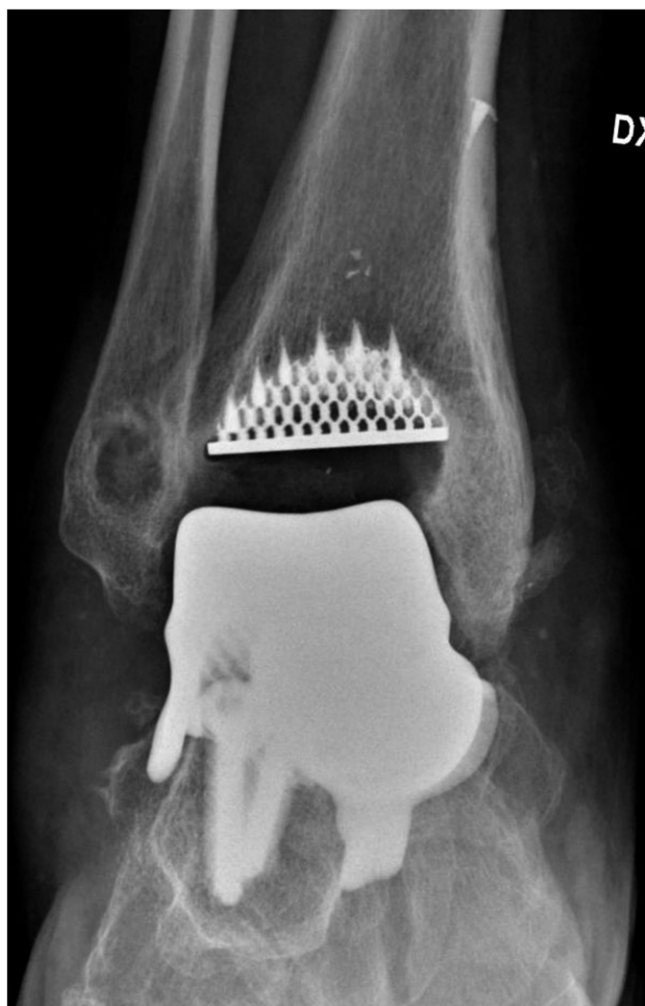
Fig. 3. Post-op total ankle replacement: frontal view. The postoperative frontal view radiograph of the ankle joint replacement shows the volume of the tibial implant and the alveolar shape. It was designed to fill the hole left in the distal tibia by the removal of the screw and ligament washer for ligament reconstruction. The polyethylene inlay has restored the joint space. The range of motion of the ankle is quite normal and the pain is absent or tolerable.

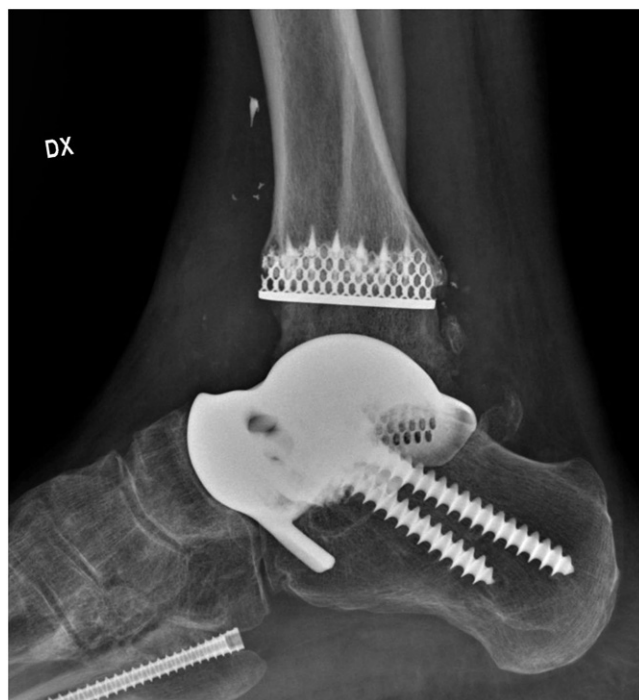
Fig. 4. Post-op total ankle replacement: lateral view. The postoperative lateral view radiograph of the ankle joint replacement shows the tibial component with its alveolar structure. The polyethylene inlay has restored the joint space.
