# Canadian Ultralight Accidents in Water (1990 to 2020)

Conor MacDonald; Christopher Brooks; Ross McGowan; Ari Rosberg

MacDonald C, Brooks C, McGowan R, Rosberg A. *Canadian ultralight accidents in water (1990 to 2020)*. *Aerosp Med Hum Perform*. 2023; 94(6):437–443.

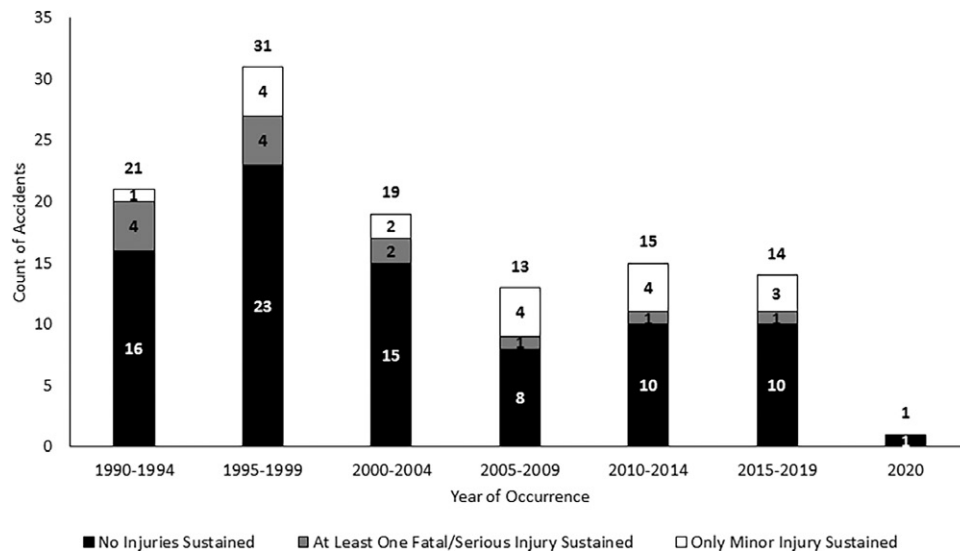
**Fig. 1.** Count of ultralight accidents terminating in water annually.

time, stratified by the number of accidents in which at least one fatal/serious injury or only minor injury had occurred.

The number of accidents per year ranged from 0 (2011) to 13 (1997), with a median of 3 and an interquartile range of 3. **Fig. 1** shows the count of accidents per 5-yr span during this
